ARCADIA  
RESTORATIONS

Conditions Assessment Report: Duxbury, Vermont  
March 14, 2023

- South Duxbury Church
- Sunshine Temperance Hall

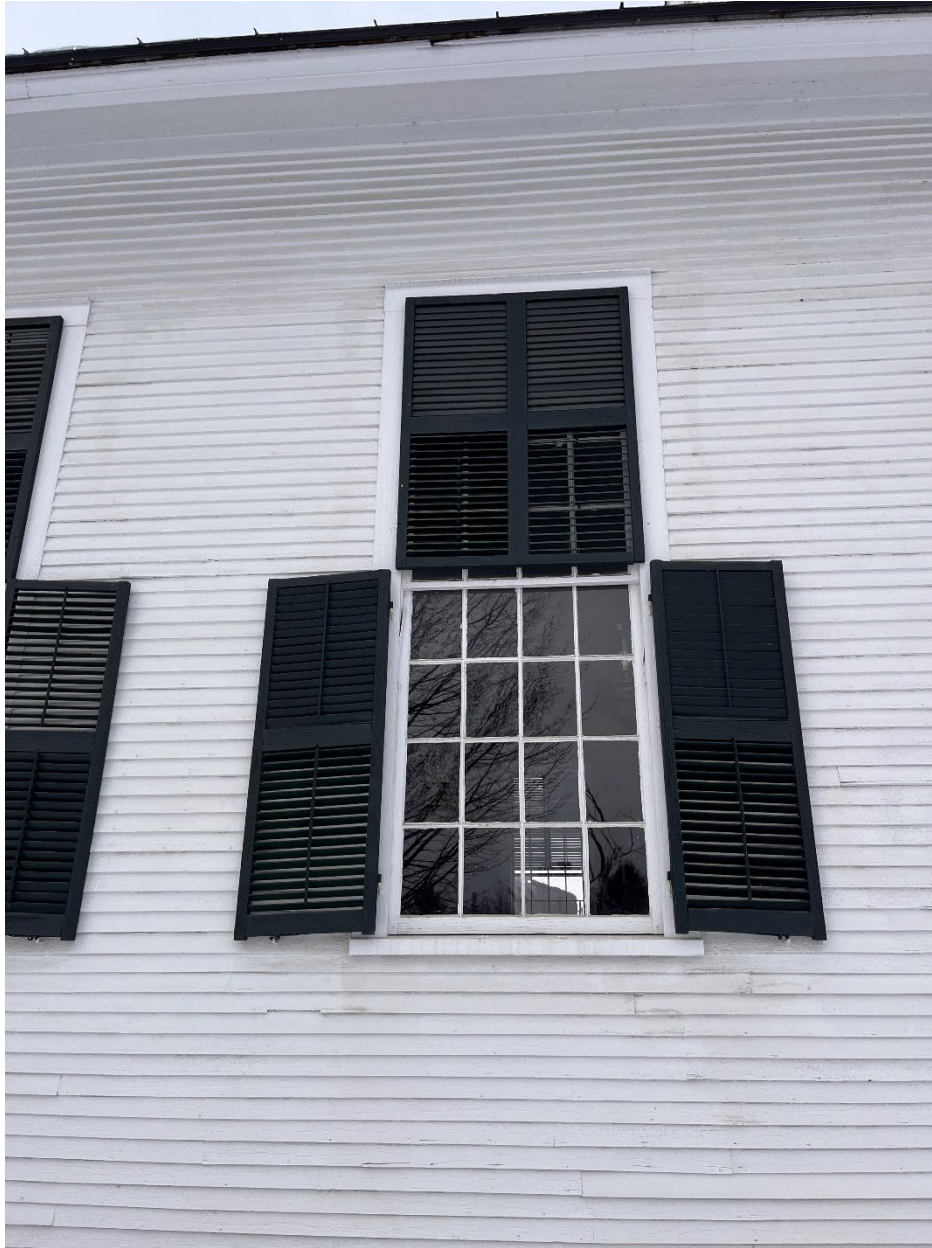
- f. **Doors and Windows:** The principal area of concern here is with regard to the windows. Historic sashes are capable of lasting indefinitely, but do require ongoing maintenance. Though these fine sixteen over sixteen windows, which are likely original, do not show any areas of outright damage, the glazing and paint is beginning to fail. The shutters, vulnerable as they are to impact and wind damage, could also do with repair, especially in cases where louvers are damaged or missing, and shutter frames are out of square. This is highly specialized work, and qualified practitioners should be sourced.

Fig. 3 – Detail window with out-of-square shutters.

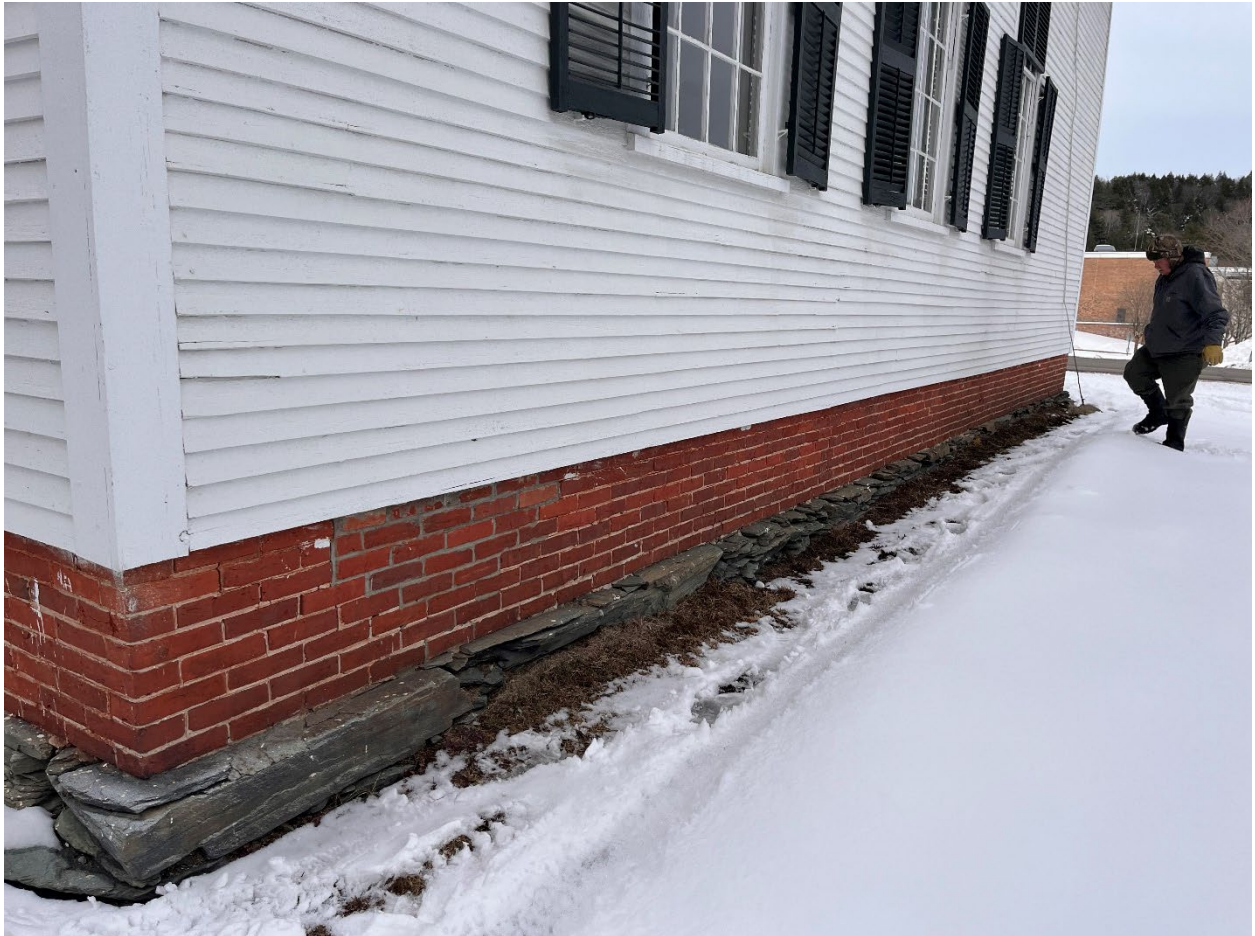
- a. **Foundation:** In a fairly typical style for its size and age, the foundation supporting the church around its perimeter consists of dry-laid fieldstone below grade, with a few courses of stone visible above ground level. Approximately eight courses of brick are laid atop the fieldstone in order to support the frame of the building itself. Over time and due to the action of frost heaving, plus the accumulated pressure of snow banking up after falling from the roof, some areas of the foundation have shifted, particularly visible in the brick courses. Though the condition of the foundation as a whole is largely good, these areas are visibly deflected out of plumb, most notably along the church's north wall. Some other areas with more minor degrees of settlement display this movement in the form of failed mortar and brick courses which have shifted out of place. In the west foundation a small opening in the brick permits the inspection of the crawl space beneath the church. This space appears to be remarkably dry and draining reasonably well, as no floor timbers which were capable of being viewed from this vantage point showed evidence of moisture-related rot such as brown fungus. Indeed, many of the round log joists still retained their bark, the loss of which is often a sign of cyclical wet and dry conditions. Each transverse carrying beam in the floor, located in the plane of each bent of the frame, is supported by a pair of evenly-spaced fieldstone piers. Though it could not be stated with any certainty, the consistency in the style of laying each pier plus the patina on the stone suggests that these may be original to the building. Regardless of their age, these piers are supporting the transverse carrying beams with remarkable straightness. It is difficult to conceive of a system of dry-laid stone floor supports that could be in better condition. The floor system does not appear to have suffered any damage as a result of cyclical loading from above.

Fig. 4 – South foundation wall; note brick courses above dry-laid fieldstone.

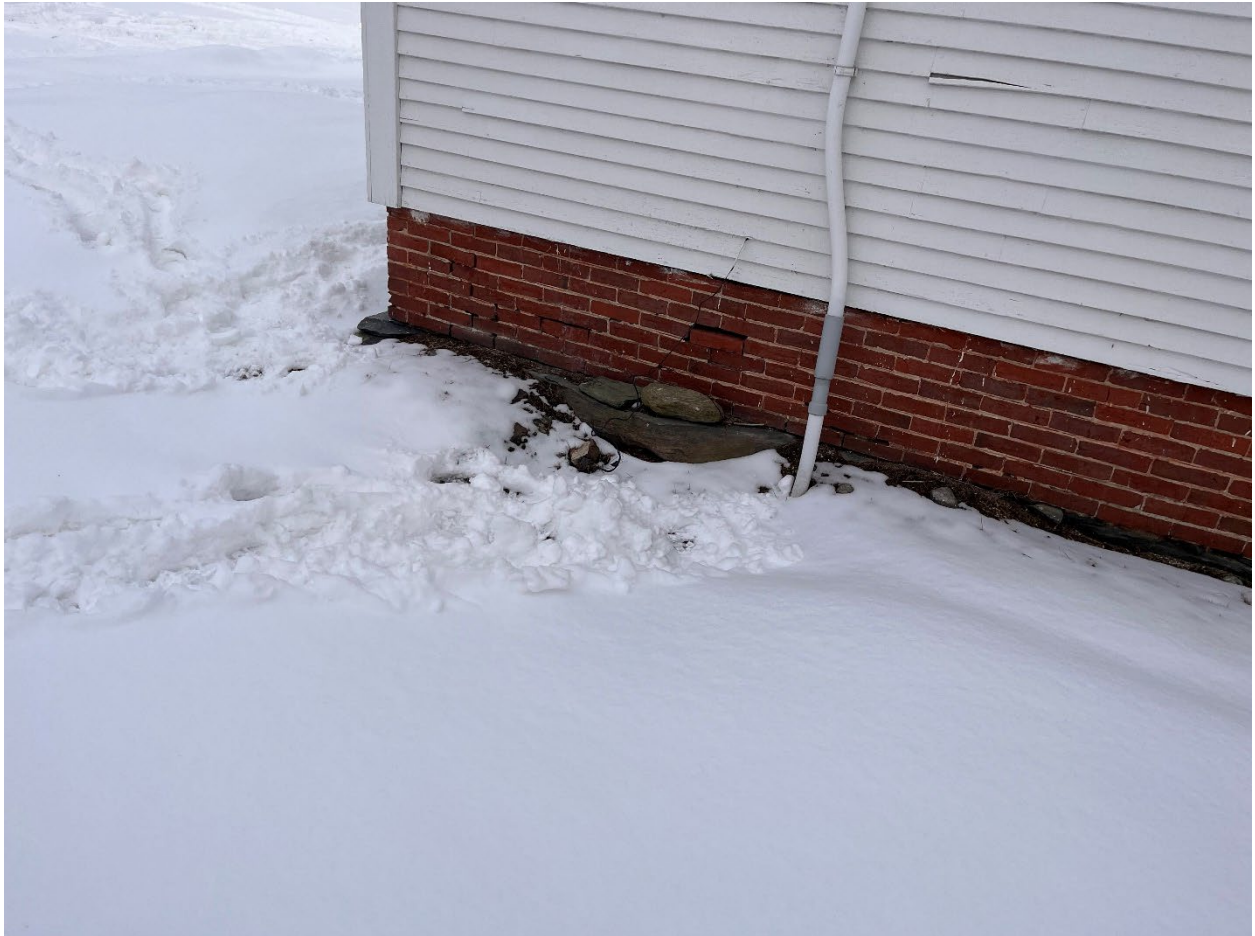
Fig. 5 – Northwest corner foundation wall; note missing mortar and loose bricks.

If any action were to be taken with regard to repairing the foundation, it should be to employ the services of a qualified historic stonemason and bricklayer to create recommendations for straightening the sections of wall which have moved out of plumb, and if repair here is impractical, exploring options related to shifting the load on the north foundation wall to be supported inboard of the north sill, such as onto additional piers or a shear wall, and replacing the brick entirely. Other smaller damaged sections should be repaired and repointed as necessary to forestall ongoing deterioration.

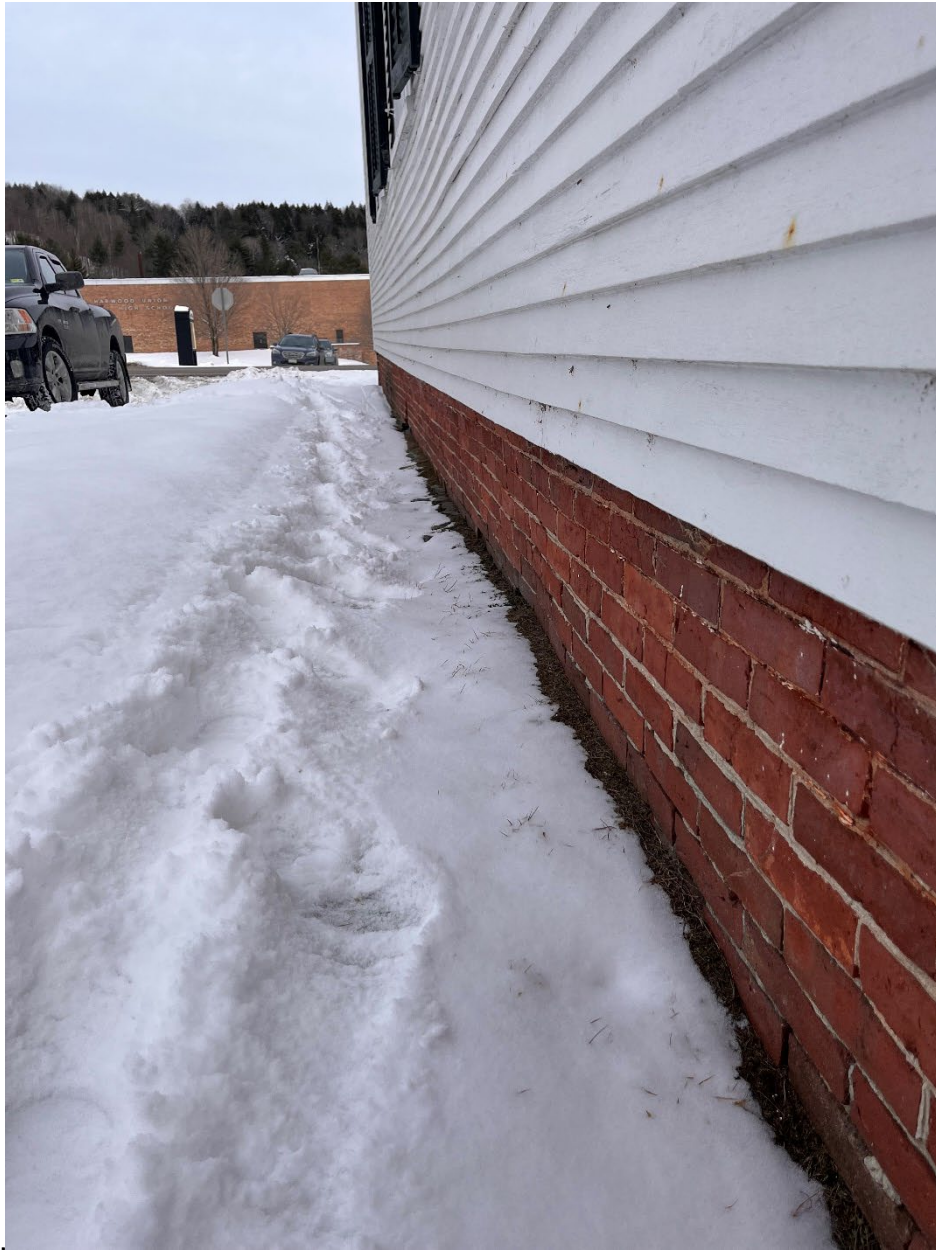
Fig. 7 – North foundation wall; note out-of plumb condition of the brickwork and failed mortar.

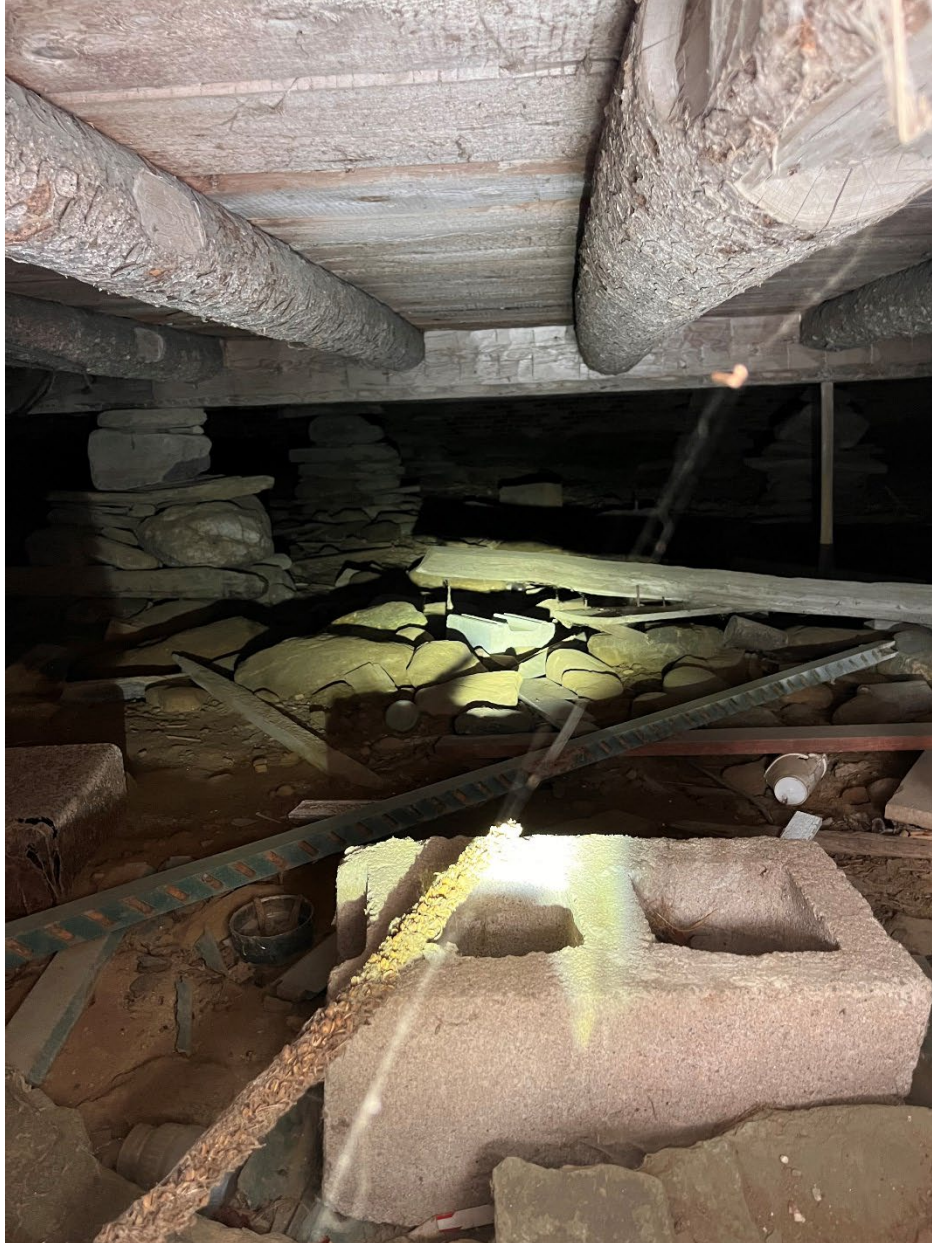
Fig. 8 – View into the crawlspace beneath the church, in overall excellent condition.

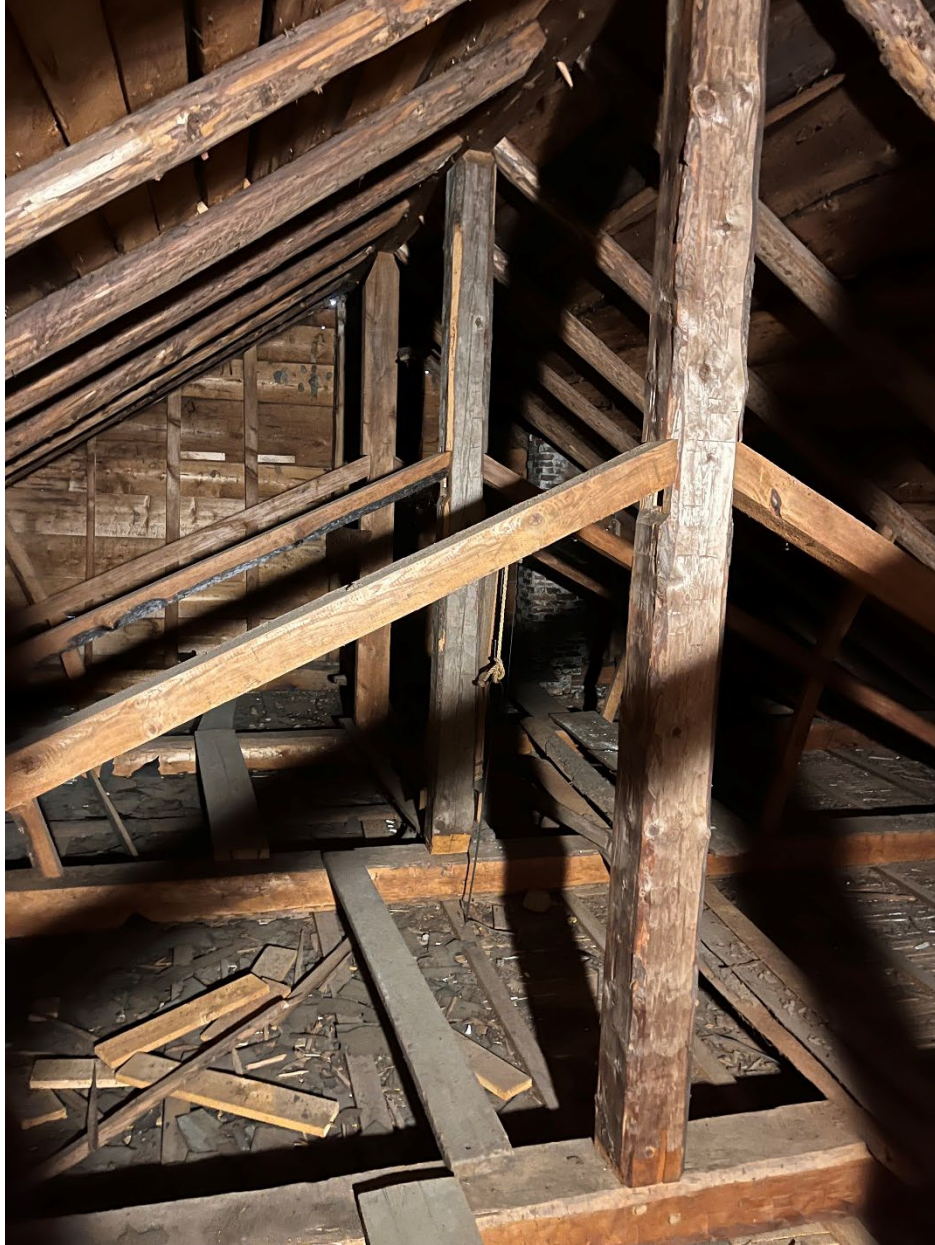
- b. **Frame:** The timber frame of the church is only visible in the crawl space and attic. In a manner fairly typical for the age of the church, members of relatively small dimension, such as braces, are vertically-sawn. Larger timbers such as tie-beams and floor carrying beams are hewn, and of remarkably high quality timber. The floor joists beneath the sanctuary, as well as the rafters, are log poles with one face hewn flat for board fastening. Though it is debatable whether the roof system consists of true trusses, the hewn five-sided ridge beam is supported by hewn kingposts which rise from the midpoint of each tie-beam to tenon into it. Whereas a more traditional kingpost truss would include principal rafters in each bent, this roof relies rather on round pole common rafters which tenon into the ridge beam. Given this, rather than the kingposts being diagonally braced up into principal rafters, they are instead diagonally braced down to the tie-beams beneath. The pitch on these braces is very low in order to distribute the load on the kingposts downward as close as practical to where the tie-beams are supported by the wall posts. This, plus the relatively low pitch of the roof, has created strain at the tie-beam ends which may at one time have resulted in some degree of failure. Particularly in the case of the south end of the second bent from the east, the rafter tail and plate are being restrained by large and relatively new through-bolted steel brackets. One other repair appears to be at the second bent from the west gable end of the church, which includes a later sawn kingpost. The repairs present in the roof system are of high quality and appear to be substantial, and stable as a result. Short of removing the entire roof system to replace any damaged timber, these repairs, though perhaps non-historic in nature, are an admirable compromise to help resist outward thrust at the rafter plate level. No other areas of the frame were visible which displayed any un-addressed damage.

Fig. 10 – Kingpost roof system.

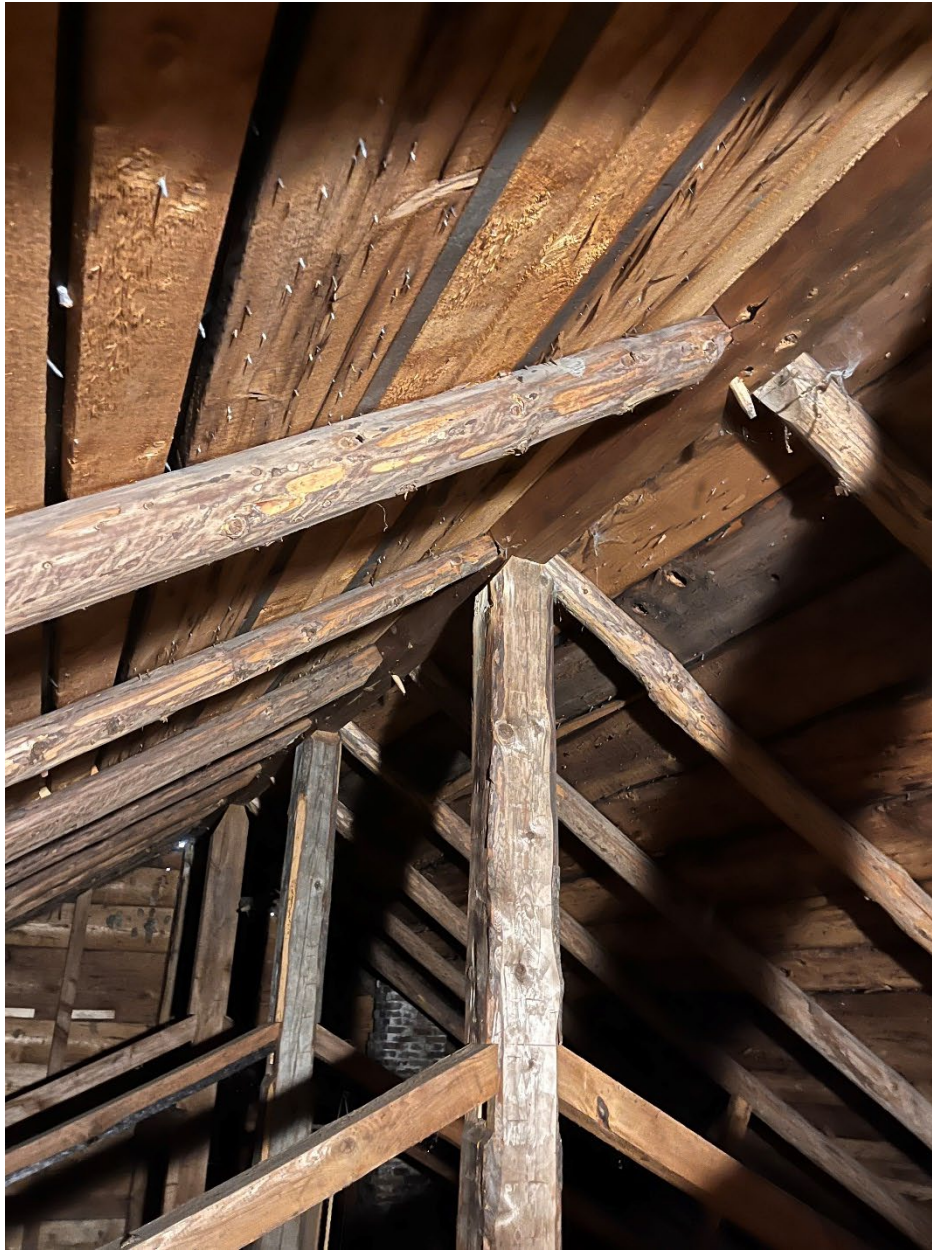
Fig. 11 – Detail view of the common rafters, kingposts and ridge beam.

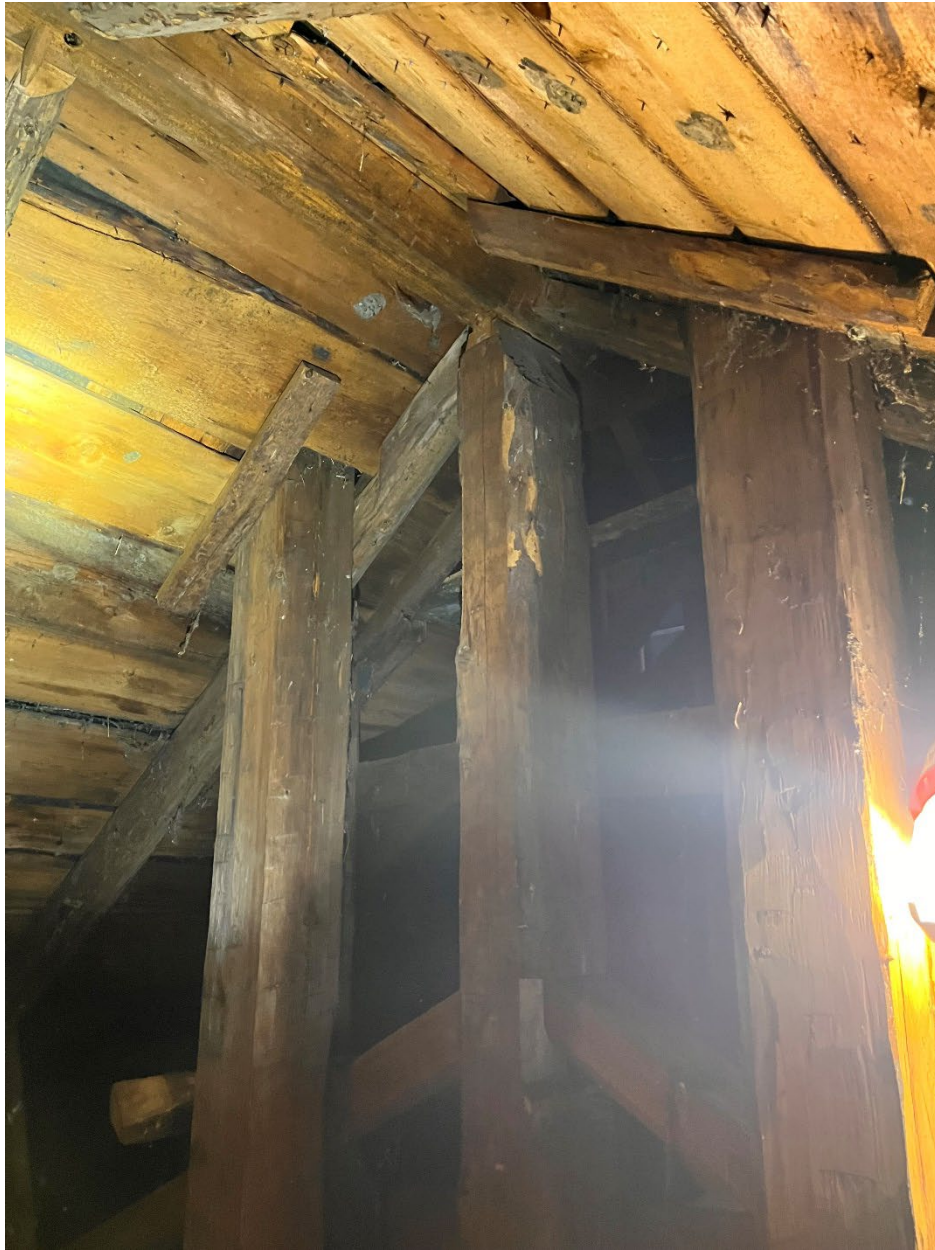
- c. **Spire:** It is somewhat difficult to fix an exact date for the construction of the spire. The lowermost square base's timber frame is not a great deal later than that of the church itself, the only evidence of its having been added being that the ridge beam was originally continuous along the entire length of the church. In its current form the ridge beam is truncated at its intersection with the base of the spire, but a small section remains in the length of roof east of the tower base which frames up the east gable end.

Fig. 12 – Lower belfry framing.

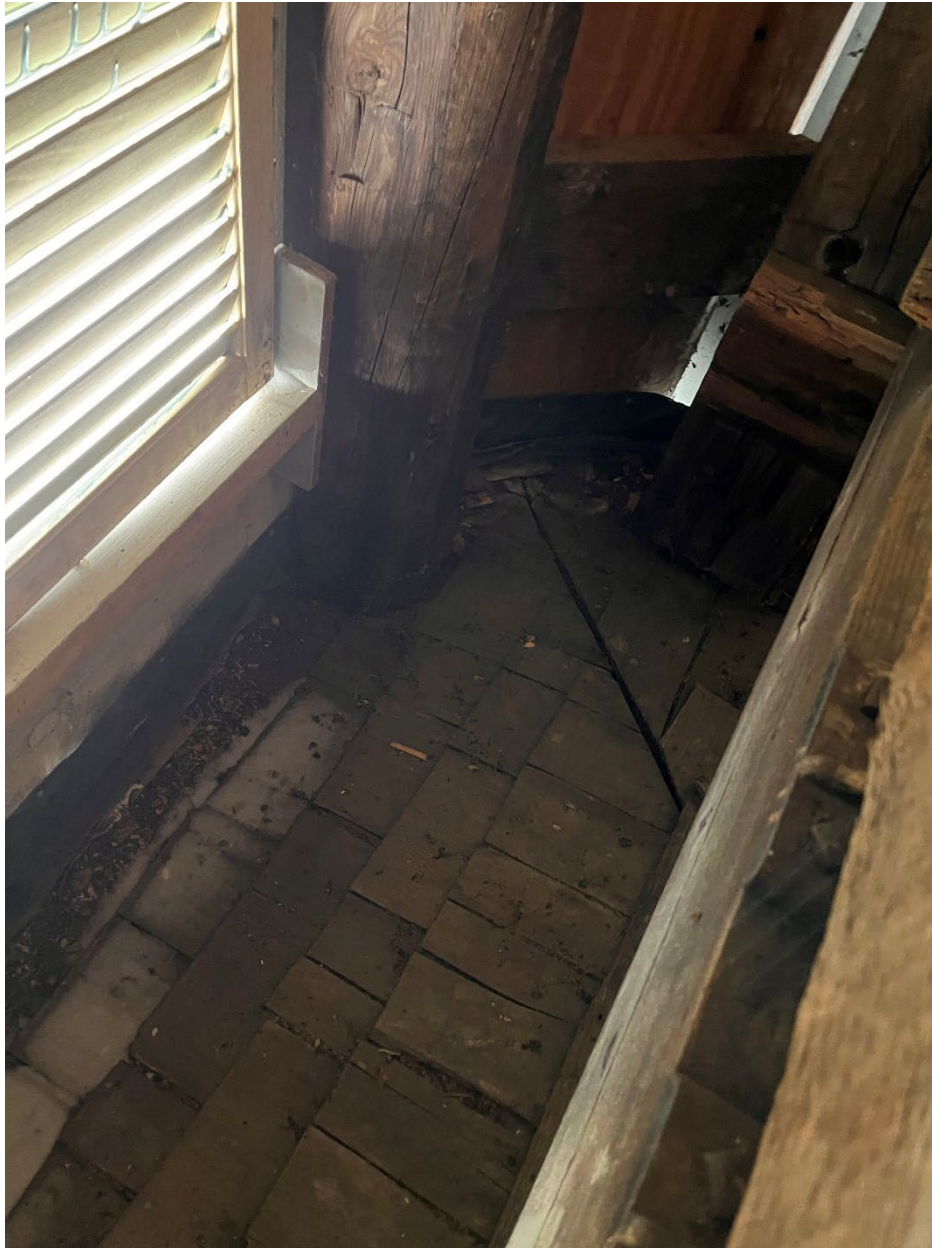
The base of the spire is capped by a shallow hipped roof which still bears a covering of unpainted cedar shingles within the perimeter of the belfry octagon. The center of this roof is pierced by the access opening directly beneath the bell carriage, which, rather than being a small timber frame, is held together with large iron spikes. The octagon framing is out of hewn softwood timber secured with wooden trunnels. The bell itself bears a patent date of November 1862, which would perhaps indicate that the square lantern was built and roofed shortly after the church itself, and that at roughly the same time or a few years later the octagon was constructed, the bell installed, and access cut through the shingled surface. The slender upper spire may be a later reproduction, consisting as it does of fairly modern framing lumber with only light weathering and patina. Overall the steeple is in excellent condition, and not suffering from the ingress of water and birds which plague many other similar structures.

Fig. 13 – Lower belfry roof shingling; bell carriage in the right foreground.

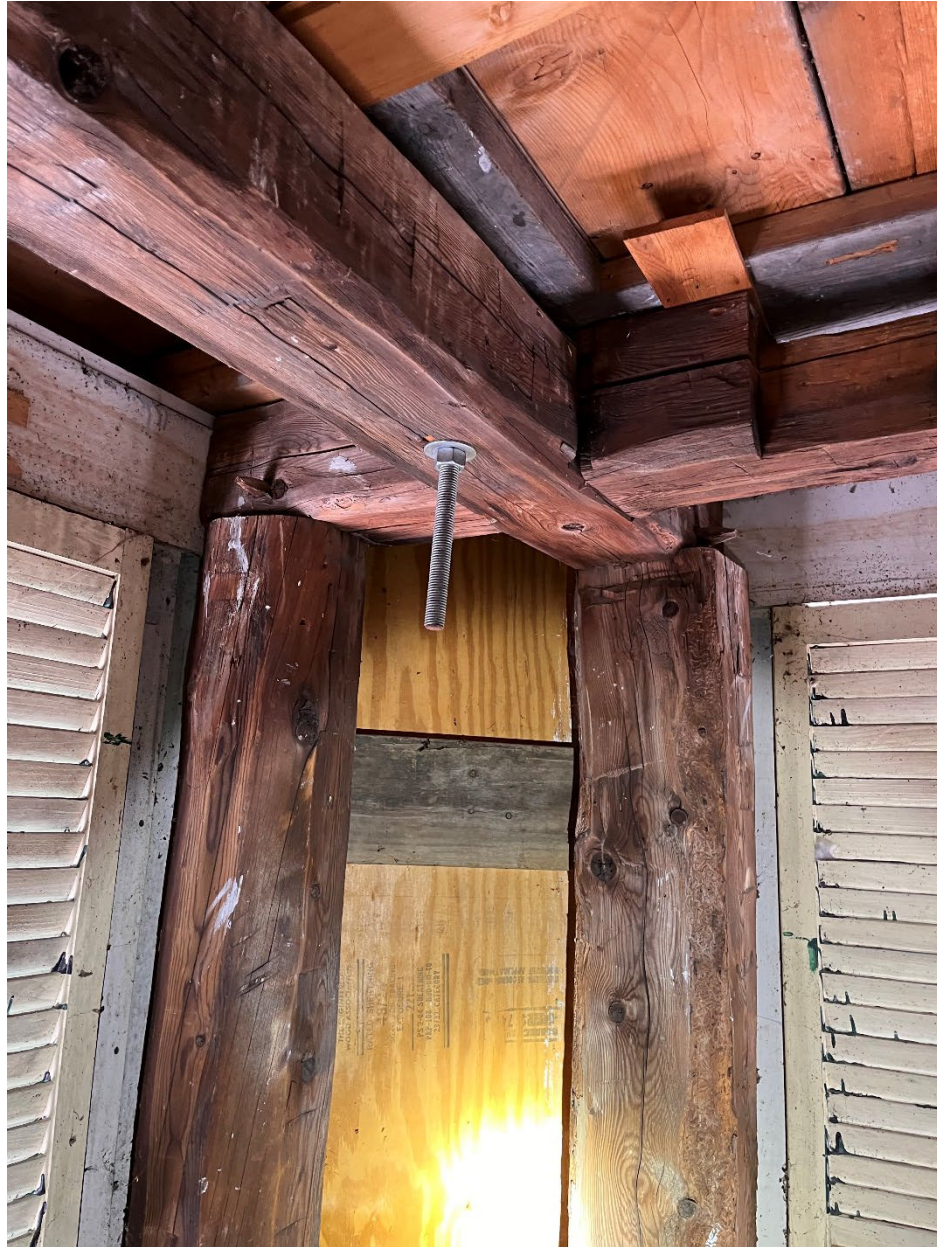
Fig. 14 – Detail view of belfry framing; note the modern through-bolt securing the replacement upper spire to the historic belfry timber framing.

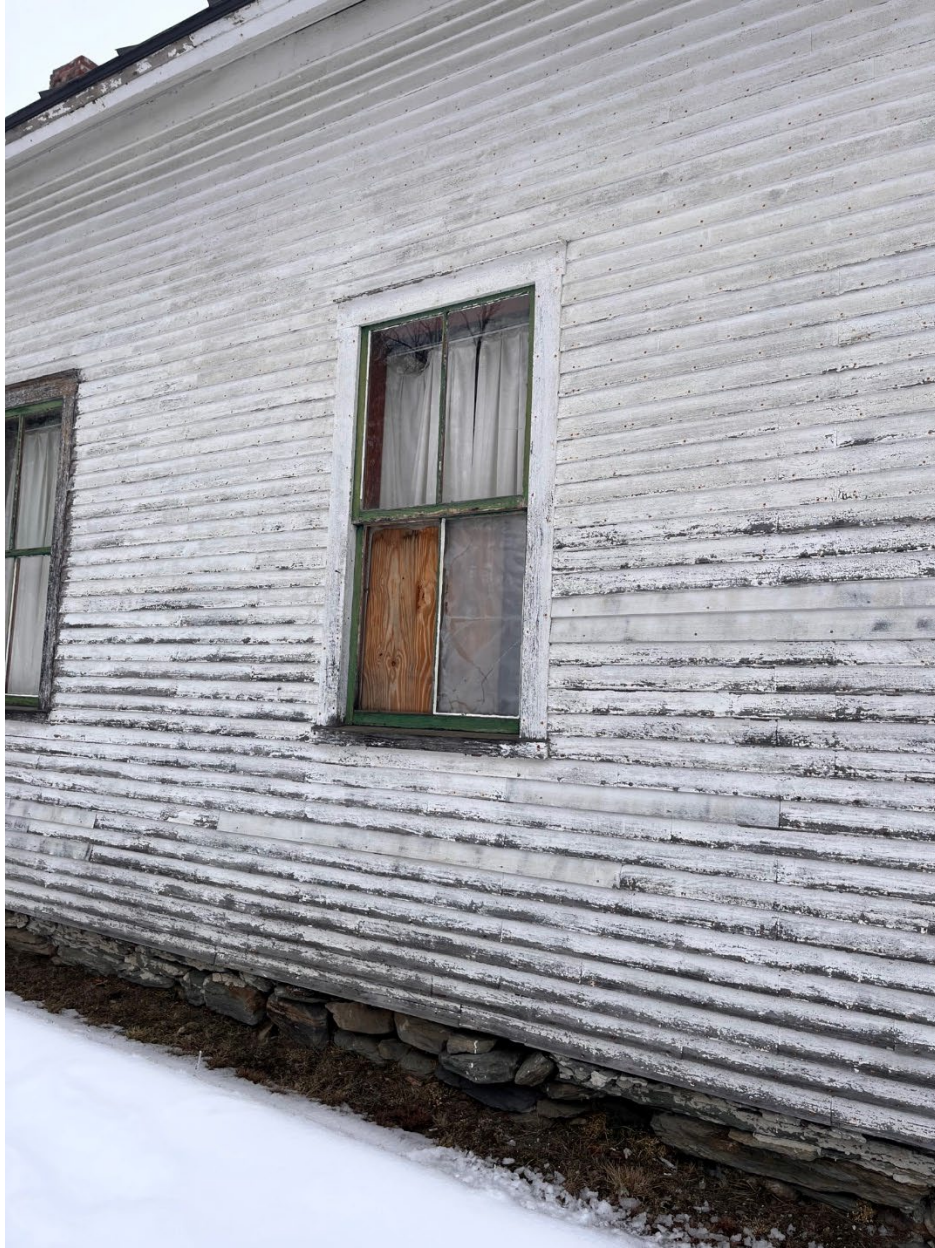
- b. **Foundation:** The building rests atop a few visible courses of fieldstone which was likely originally dry-laid but has been mortared after the fact in a number of locations. It could not be readily determined how far the fieldstone foundation continues below grade, but regardless, given the lightness of the building and its sporadic use, the foundation is adequately supporting the building around its entire perimeter, despite the occasional shifted stone. Though the foundation does not require any repair as such, it should be monitored for any accelerated displacement.

- e. **Doors and Windows:** Though it appears that the doors and windows have had some patching and repair over their history, they have suffered a similar degree of weather-related damaging which has affected the clapboards and paint. The raised-panel entry doors have a raised grain due to the weathering of bare wood, and the two-over-two windows have failed glazing, shrinking joinery and missing glass. With a qualified contractor it should be a straightforward task to remove, restore, and reinstall the doors and windows with new glazing, repaired woodwork, fresh paint and unobtrusive weather stripping in order to regain their historic integrity, improve thermal performance and restore functionality.

Fig. 17 – Detail view of damaged window, siding and fieldstone foundation.

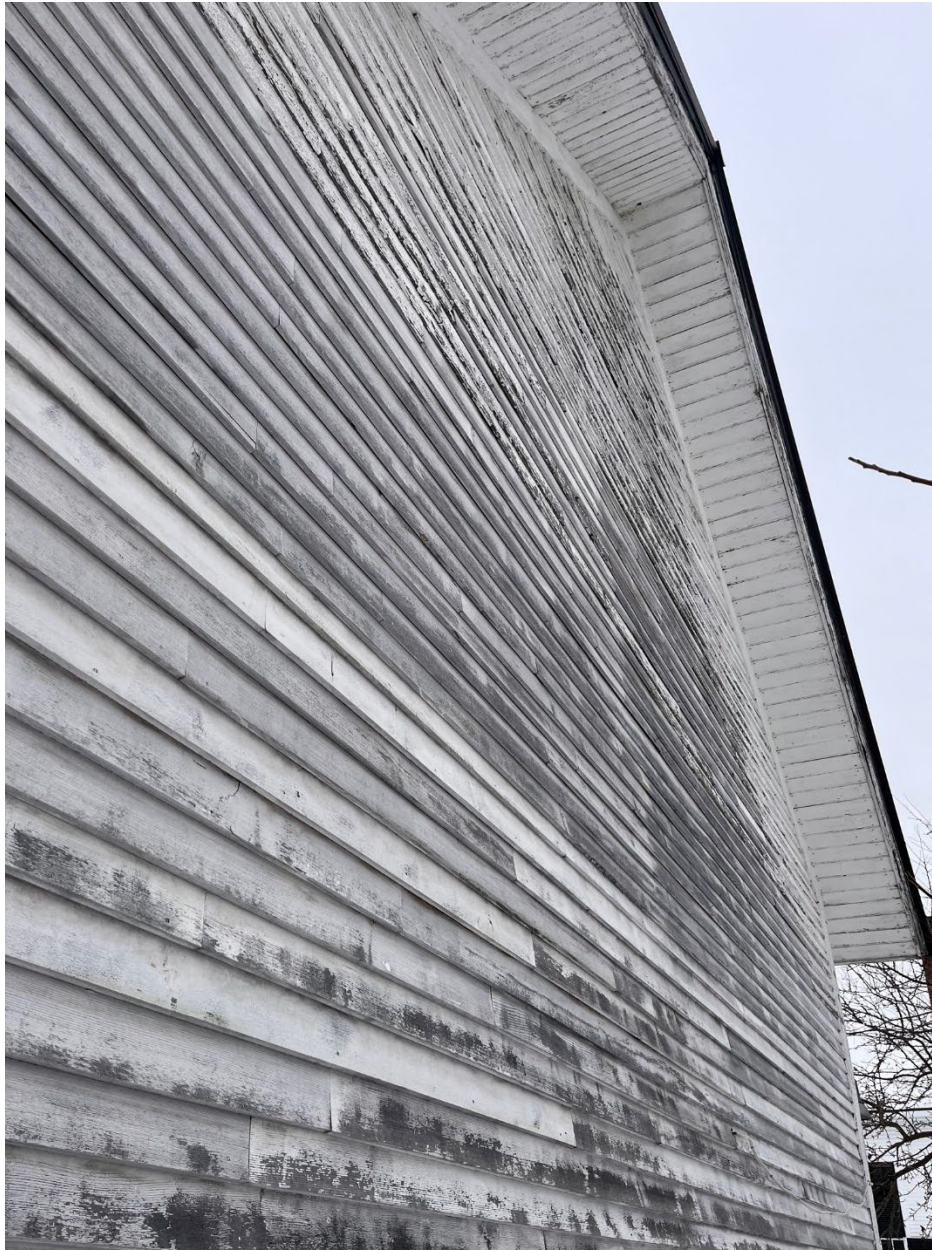
- d. **Trim and Paint:** Unlike the adjacent church, the paint on the Temperance Hall is in very poor condition, and should essentially be considered to be in a state of failure. The paint may indeed be original in some locations, as certain pieces of trim, such as a window casing in the south wall, retain their paint to a much greater degree, suggesting that they are replacement elements. As the paint continues to flake off of the building, the small areas of damaged clapboards largely restricted to the lowest courses will continue to become more widespread at an accelerated pace. A comprehensive repainting should be considered a priority task. As with all historic buildings, it is most prudent to assume that any paint contains lead. Given that in this case it may well be that the current paint application is original, the presence of lead paint is all but a certainty, and a painting contractor qualified in handling toxic materials should be sought.

Fig. 19 - Detail view of west gable end – note failed original paint, intact original paint, and replacement clapboards in the left foreground.

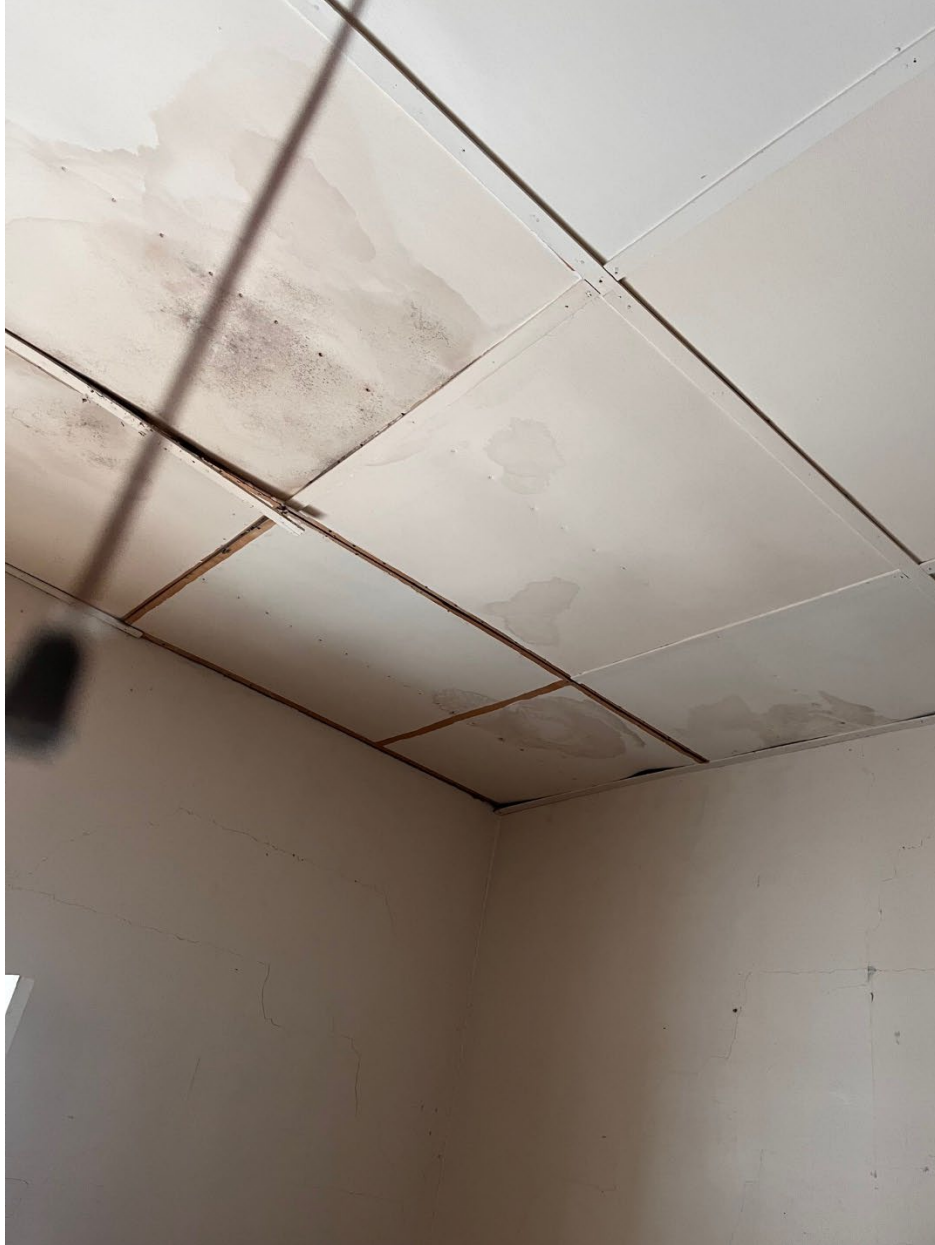
Fig. 22 – Water-stained hardboard ceiling.
