HISTORIC SITES & STRUCTURES SURVEY
District ☐ Complex ☒ Survey Form

COUNTY:	Washington		
TOWN:	Duxbury		
LOCATION:	On Route 100		
NAME OF DISTRICT:			
TYPE OF DISTRICT:			
PHYSICAL CONDITION OF STRUCTURES:			
Excellent	100 %	Good	%
Fair	%	Poor	%
LEVEL OF SIGNIFICANCE:			
Local	<input type="checkbox"/>	State	<input checked="" type="checkbox"/>
National	<input type="checkbox"/>		
THEMES:

SURVEY NUMBER:	1206-6
NEGATIVE FILE NUMBER(S):	78-A-129
UTM REFERENCES:	
Zone/Easting/Northing	
A	18 676530 4902330
B	18 676530 4902350
C	
D	
U.S.G.S. QUAD. MAP:	Waterbury, Vt.
COMPLEX INFORMATION ONLY	
COMMON NAME:	South Duxbury Church and Church Hall
PRESENT FORMAL NAME:	South Duxbury Church and Church Hall
ORIGINAL FORMAL NAME:	South Duxbury Church and Church Hall
TYPE OF COMPLEX:	meetinghouse
TYPES OF STRUCTURES:	
PRESENT USE:	church
ORIGINAL USE:	
ARCHITECT/ENGINEER:	
BUILDER/CONTRACTOR:	Samuel Cook Turner
ACCESSIBILITY TO PUBLIC:	Yes <input type="checkbox"/> No <input type="checkbox"/> Restricted <input type="checkbox"/>

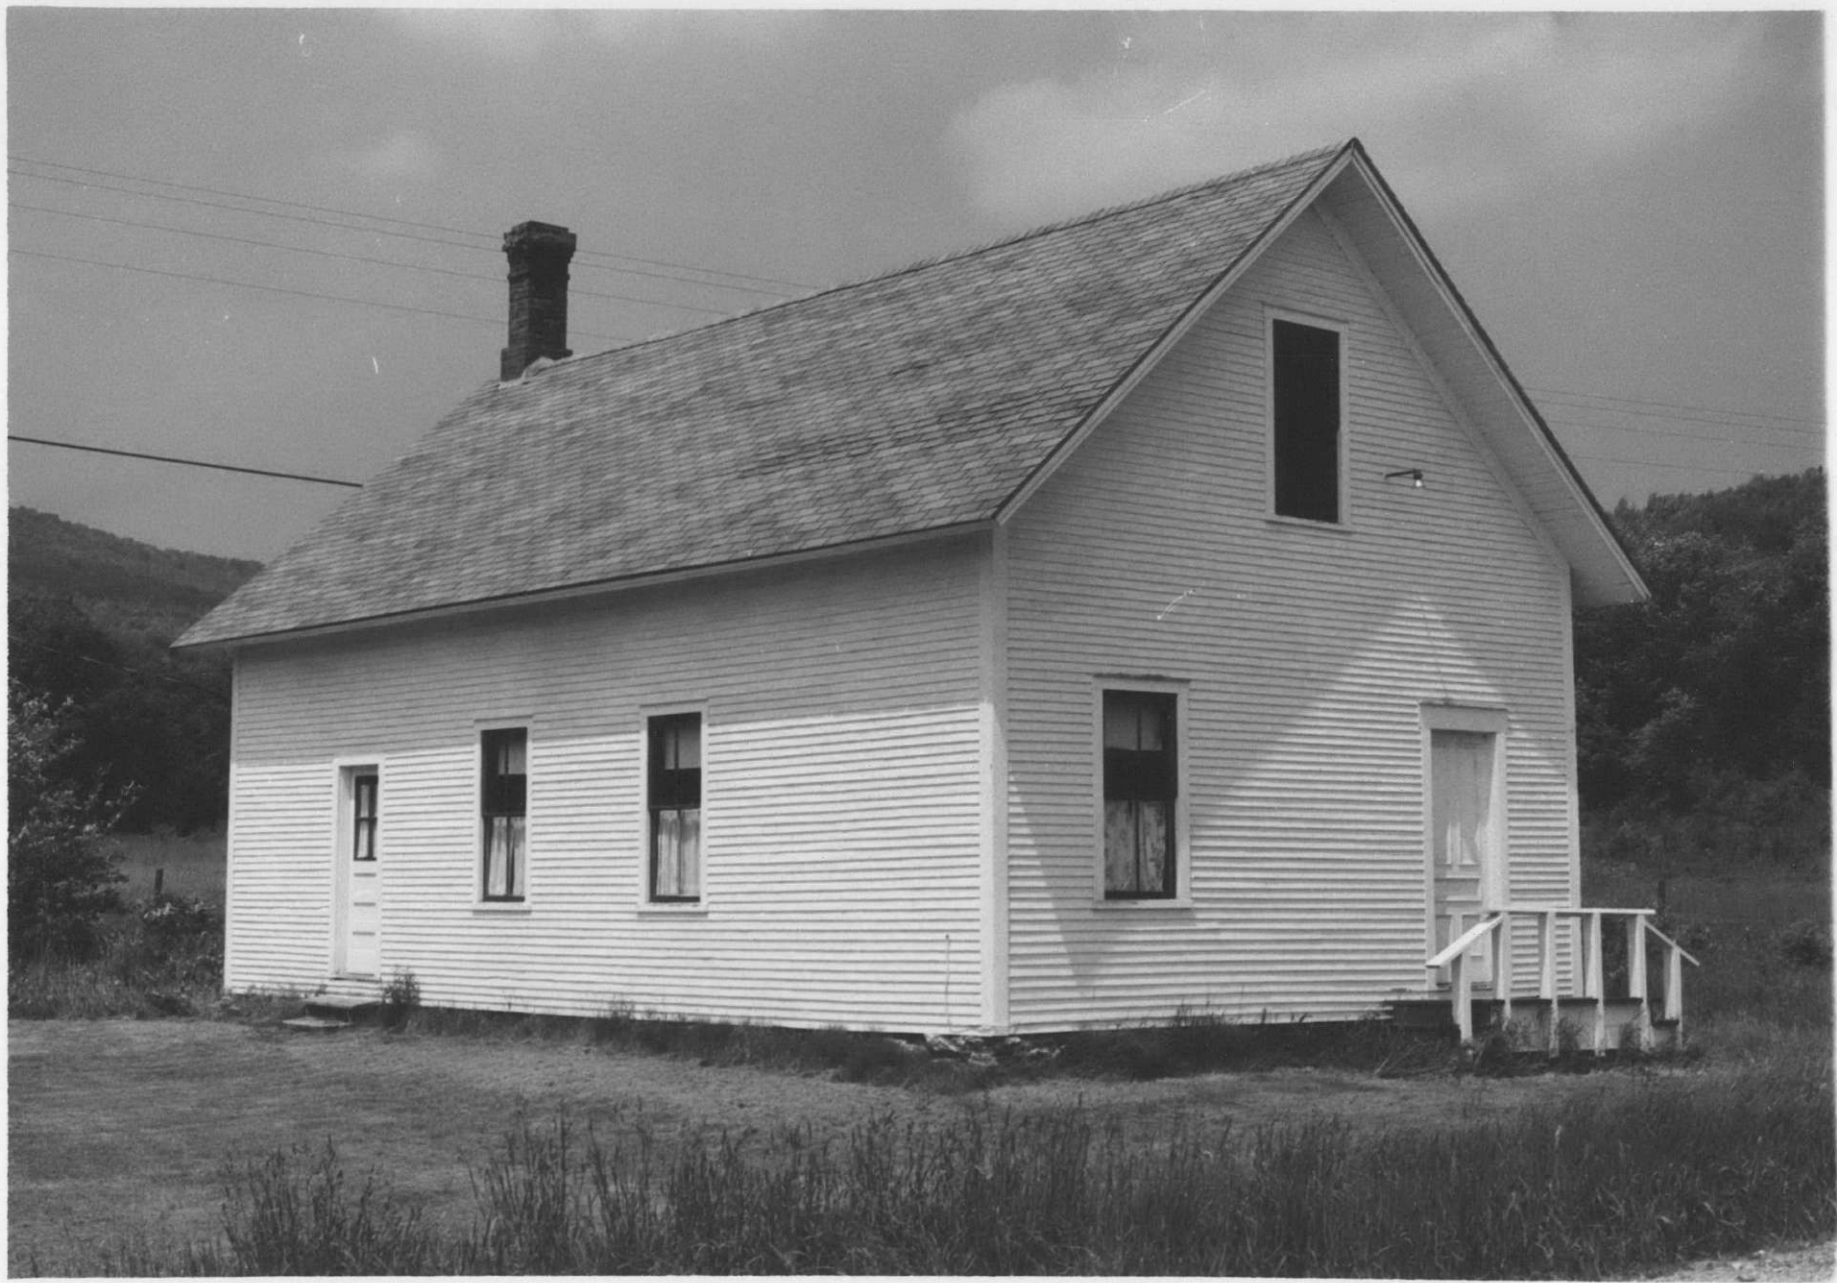
Vt. Div. for Historic Preservation
Washington County Duxbury 6/78
Church Hall, S. Duxbury, 1206.6.2
78-A-129 Nina Anderson

MAP NUMBER: 2	DATE BUILT: 1890's	SURVEY NUMBER: 1206-6 #2
FUNCTIONAL TYPE:		NEGATIVE FILE NUMBER: 78-A-129
COMMON NAME: church hall		OWNER:
DESCRIPTION: This church hall rests on a field stone foundation. The clapboard building is 1 1/2 stories, and has a gabled asphalt roof which runs East-West toward the road. There is a rear brick interior chimney. The principal facade (east) is 2 bays wide. On the right side of the main facade is a side entry, with a recessed panelled door with a simple narrow surround. To the left of the door is a 2/2 sash with plain surround. In the gable peak is a 2/2 sash. On the left (south) elevation are 3 bays. There is a recessed panelled and 4 light door with a narrow surround. To the right of the door are 2, 2/2 sash. On the right (north) elevation are 4, 2/2 sash.		
MAP NUMBER: 3	DATE BUILT:	SURVEY NUMBER: 1206-6 #3
FUNCTIONAL TYPE: shed		NEGATIVE FILE NUMBER:
COMMON NAME:		OWNER:

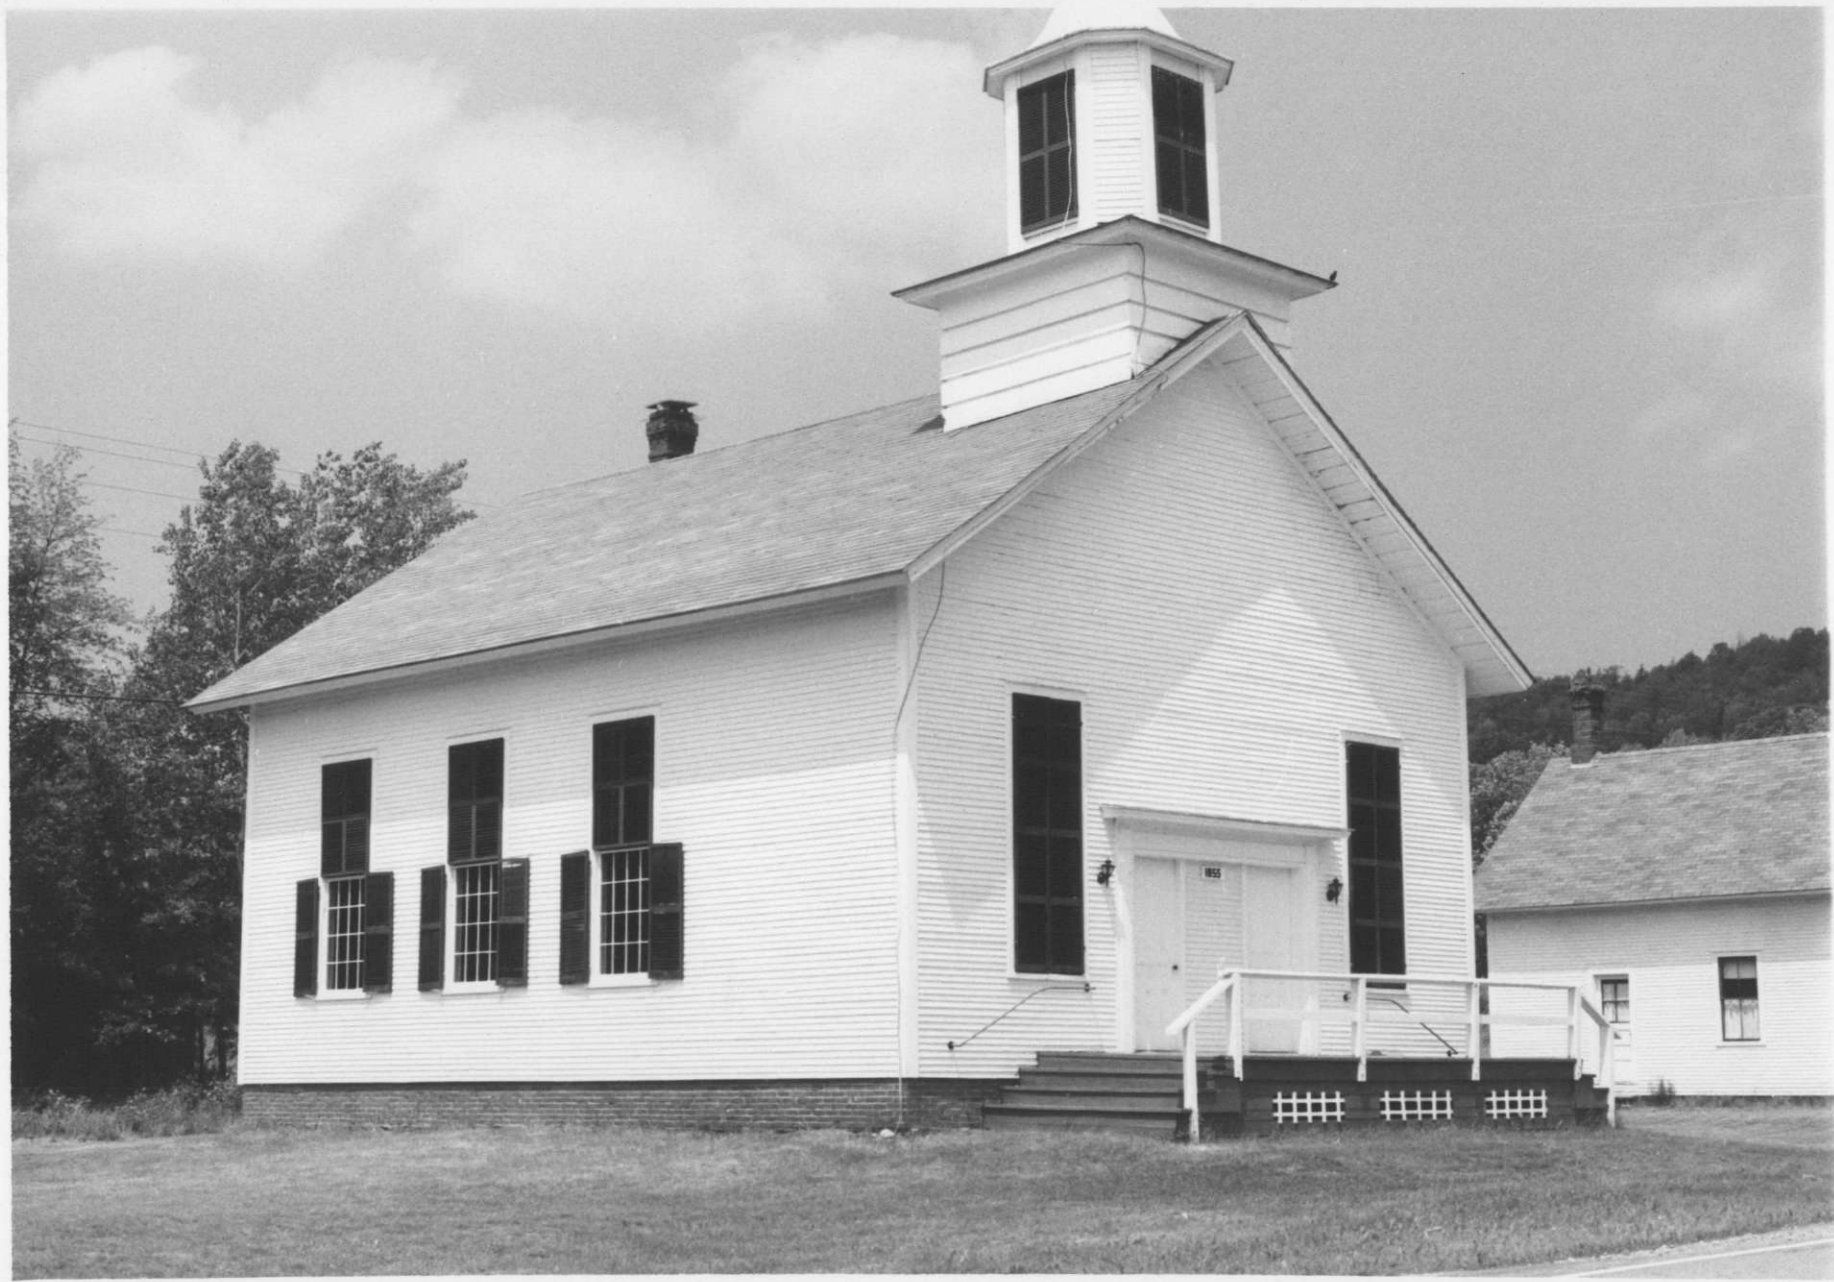
Vt. Div. for Historic Preservation
Washington County Duxbury 6/78
Church, South Duxbury, 1206.6.1
78-A-129 Nina Anderson

OUTSTANDING COMPONENTS OF DISTRICT <input type="checkbox"/>		COMPLEX <input checked="" type="checkbox"/>
(Include individual survey number ONLY if surveyed individually.)		
MAP NUMBER: 1	DATE BUILT: 1855	SURVEY NUMBER: 1206-6 #1
FUNCTIONAL TYPE:		NEGATIVE FILE NUMBER: 78-A-129
COMMON NAME:		OWNER:
DESCRIPTION: This clapboard church rests on a stretcher bond brick foundation. The 2 story Church/Meetinghouse has a gabled asphalt roof which runs East-West toward the road. There is an interior brick rear chimney with a corbelled cap. The 4 bay principal facade consists of two entries each of which has a recessed 7 panel door; separated by a clapboard area. They are framed by a simple narrow surround and share a common cornice. A deck crosses the main entry. Two elongated 8/8 sash with plain surrounds and louvered shutters flank the main entry. Cornerboards frame the building. An octagonal plan louvered belfry on a square base is centered on the east elevation. The spire is topped by an excellent weathervane. Both the South and North elevation are 3 bays with elongated 8/8 sash with plain surround and louvered shutters.
